FORT TOTTEN U.S. ARMY FACILITY UST CLOSURE REPORT 11 SITES

FINAL DOCUMENT

IT CORPORATION 2113 EMMORTON PARK ROAD EDGEWOOD, MD 21040

June 2001

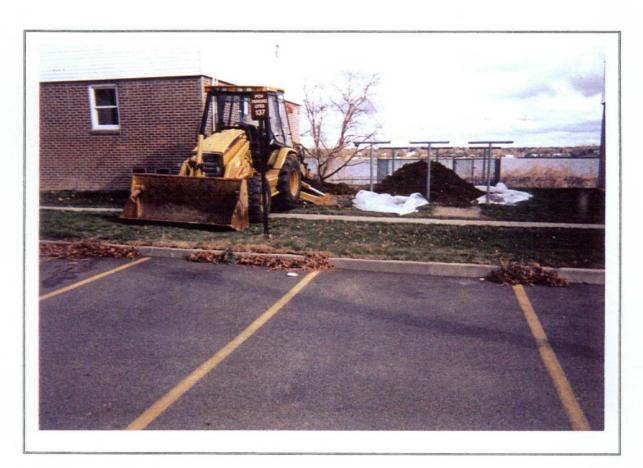
Building 137 UST - Excavating UST with backhoe.

The UST was removed and measured 10.7 ft long and 4 ft in diameter (Figure 5-1). The final excavation measured 20 ft by 10 ft and 9 ft deep. The tank was in poor condition and had holes in the bottom of the tank. The excavation contained soil mixed with historic fill type debris such as glass bottles, cans, and wood. The soil was gray and black in color with petroleum odors and PID readings up to 27 ppm. The contamination was reported to the NYSDEC Spill Hotline and was recorded as Spill No. 9910568. Approximately 20 cubic yards of contaminated soil were removed from the excavation for offsite disposal. One soil sample was collected from the base of the excavation. Sample FT137-BE1 (10-10.5 ft bgs) was collected and analyzed for VOCs and SVOCs. The sample had a petroleum odor and a PID reading of 15 ppm. The excavation was backfilled to grade with clean fill.

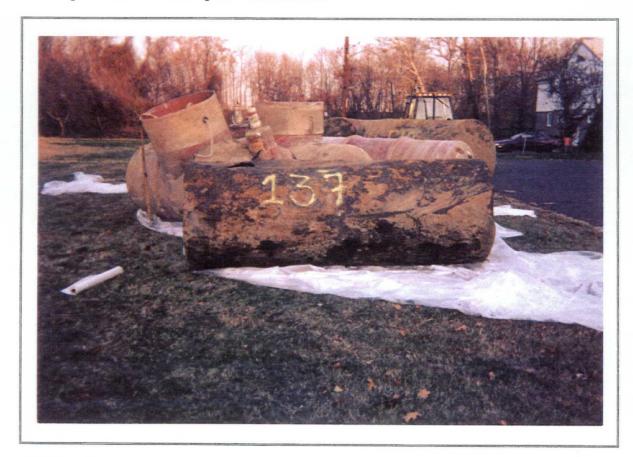
Building 137 UST - Tank temporarily staged on plastic.

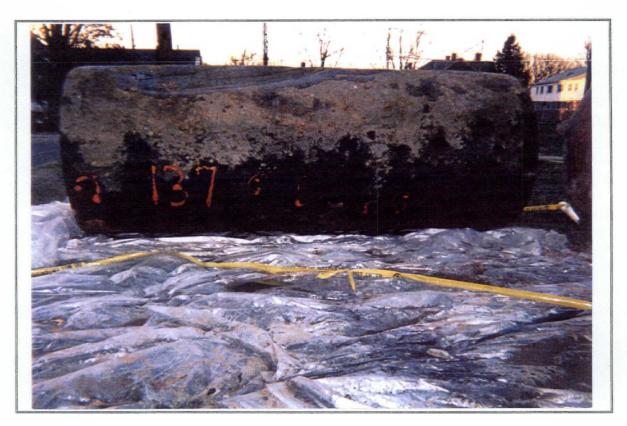
Building 137 UST - Holes in tank circled with spray paint.

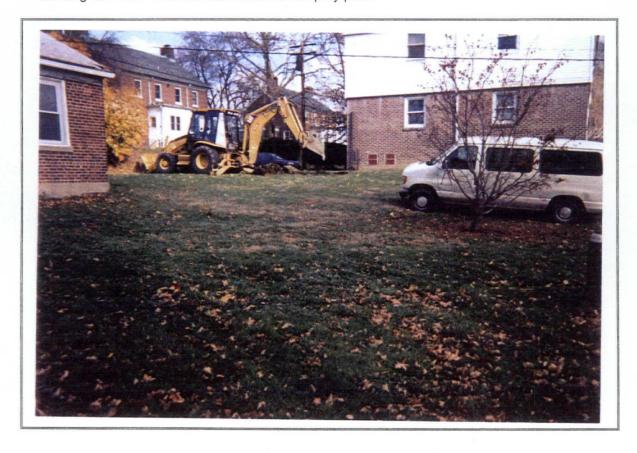
Building 139 UST - Beginning excavation of tank.

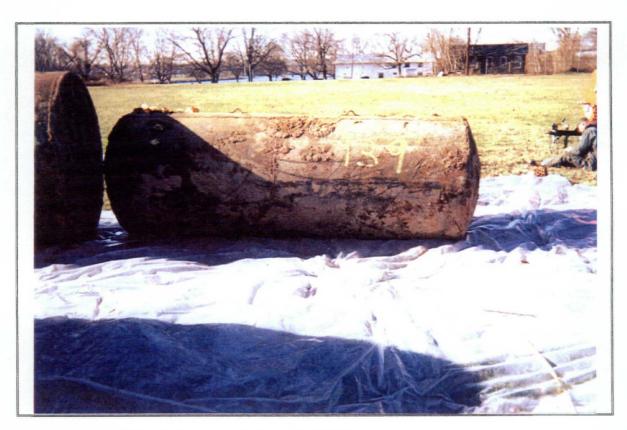
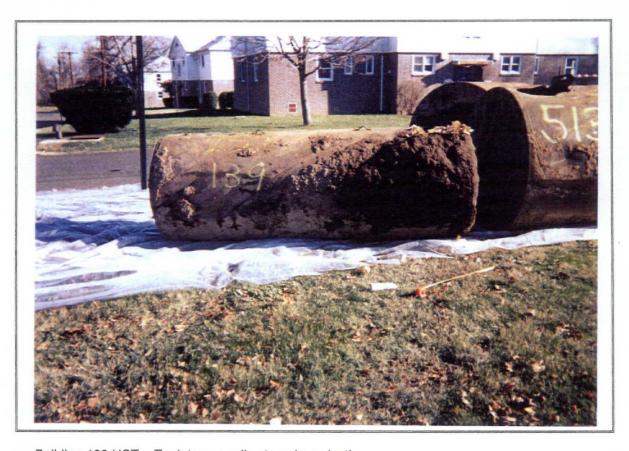
Building 139 UST - Tank temporarily staged on plastic.

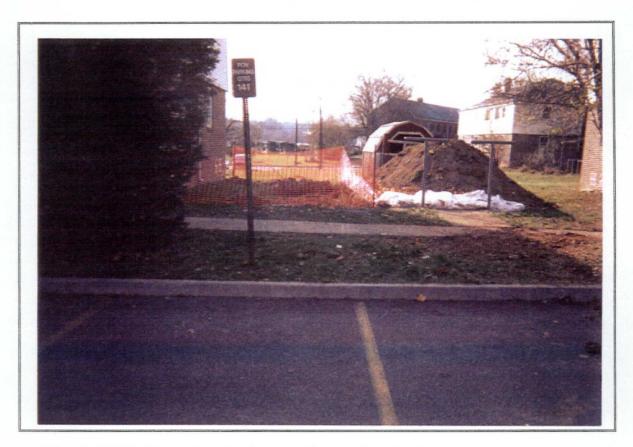
Building 141 UST – Contaminated soil temporarily staged on plastic.

Based on the elevated concentrations of VOCs and SVOCs detected at the former Building 141 UST excavation, additional petroleum contaminated soil was removed. The contaminated soil was observed at depths below 5 ft. The soil contained black, gray, and grayish-white ash and historic fill type debris such as broken glass and pieces of wood and metal. The excavated materials had a strong fuel oil odor and PID readings up to 122 ppm. The final excavation measured 17 ft by 15 ft and 15 ft deep (Figure 5-5). Not all of the contaminated soil was removed from the excavation due to the limited reach of the backhoe and the tight constraints of the working area. Groundwater was not encountered in the excavation. Approximately 50 cubic yards of contaminated soil were removed from the excavation for offsite disposal.

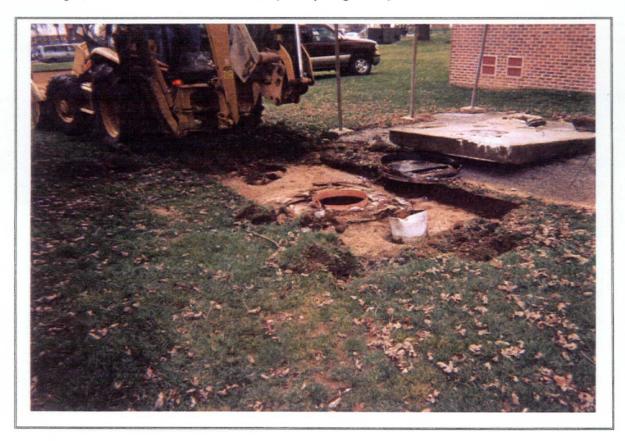
Building 407 - Beginning excavation of tank.

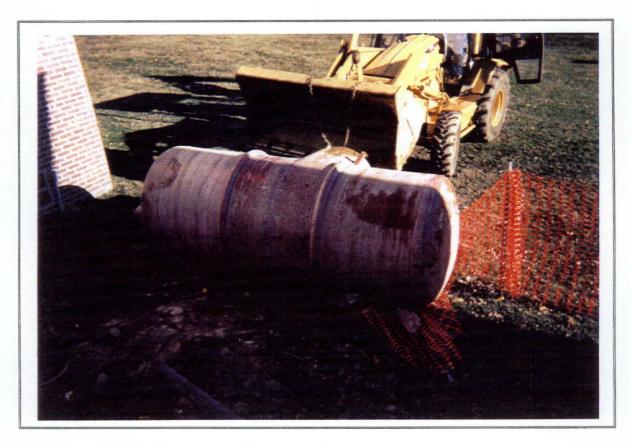
Building 407 UST - Removing tank from excavation.

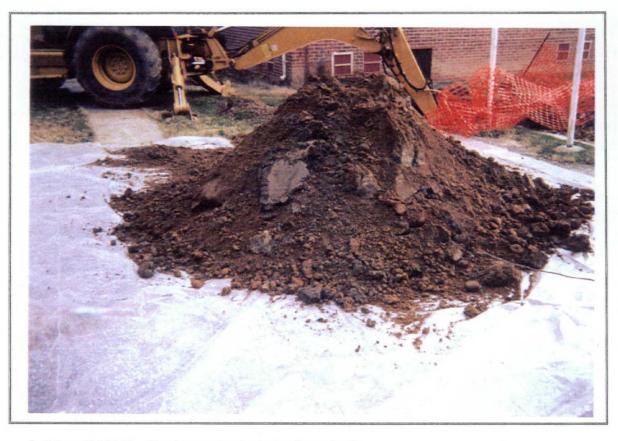
Building 424 UST - Staging contaminated soil on plastic.

Based on the elevated concentrations of VOCs and SVOCs detected at the former Building 424 UST excavation, additional petroleum contaminated soil was removed. The contaminated soil was observed at depths below 8 ft. The contaminated soil was silt and clayey-silt with a strong fuel oil odor

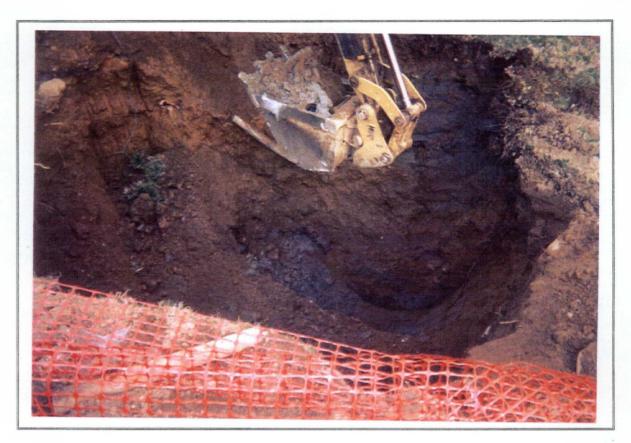
Building 424 UST - Removing contaminated soil (stained gray) from excavation.

and PID readings up to 22 ppm. The concrete pad for the former UST was uncovered at 9 ft bgs. Groundwater was encountered at 10.5 ft bgs. The final excavation measured 22 ft by 14 ft and 12.5 ft deep (**Figure 5-8**). Not all of the contaminated soil was removed from the excavation due to the limited reach of the backhoe, the very tight constraints of the contaminated soil between the concrete pad and beneath the building foundation, and the contamination extended below the water table. Approximately 25 cubic yards of contaminated soil were removed from the excavation for offsite disposal.

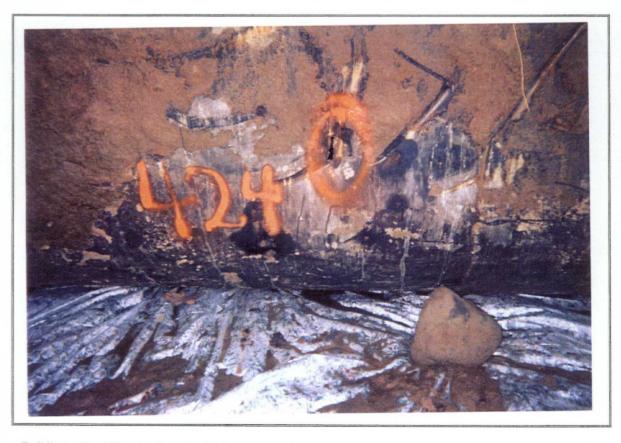
Building 424 UST - Hole in tank after removal.

The UST was removed and measured 12 ft long and 5.3 ft in diameter (**Figure 5-7**). The final excavation measured approximately 17 ft by 15 ft and 13 ft deep. The groundwater table was encountered at 13 ft bgs. The tank was in fair condition. A hole was observed in the side of the tank, which may have been caused by the backhoe during removal. The excavation contained gray petroleum contaminated soil and PID readings up to 30 ppm. The contamination was reported to the NYSDEC Spill Hotline and was recorded as Spill No. 9910389. The contaminated soil was observed to the depth of the water table. Approximately 30 cubic yards of contaminated soil were removed from the excavation. The excavation was backfilled to grade with clean fill after collecting soil samples.

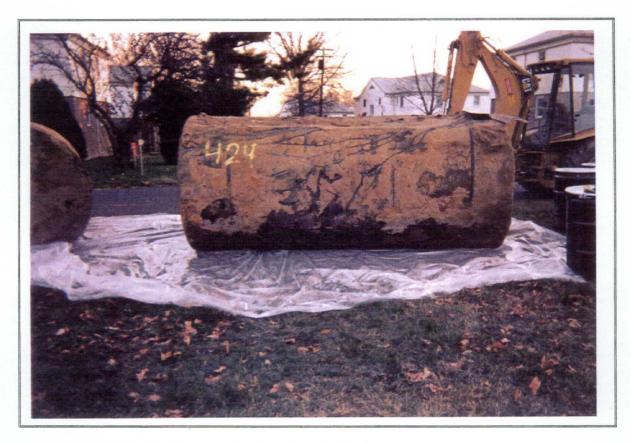
Building 424 UST – Tank temporarily staged on plastic.

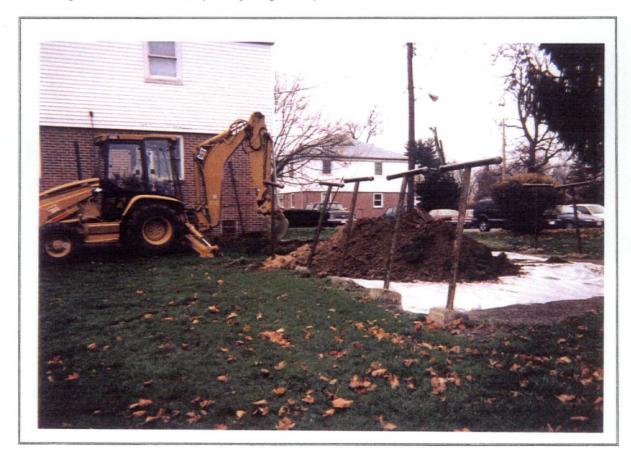
Building 427 UST - Beginning excavation of tank.

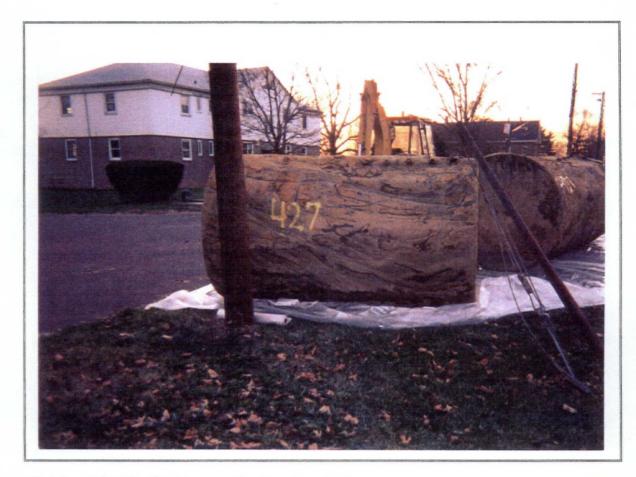
Building 427 UST – Tank temporarily staged on plastic.

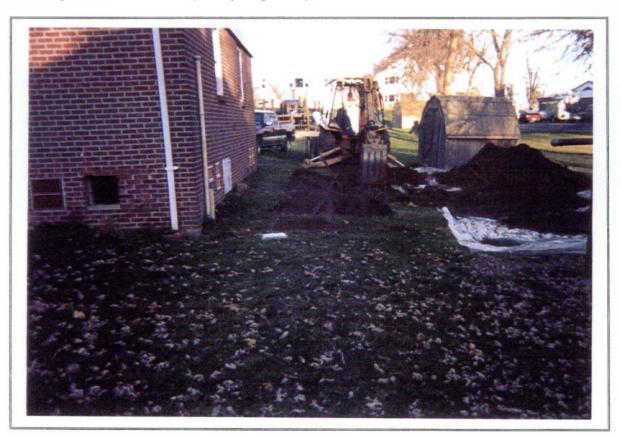
Building 430 UST - Beginning excavation of tank.

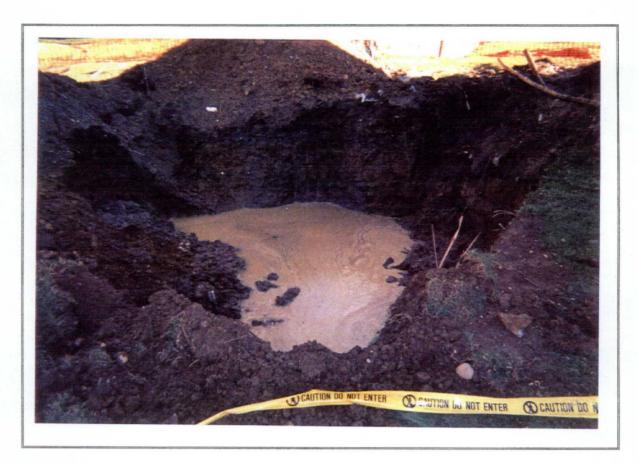
Building 430 UST - Contaminated soil (stained grayish-black) along sides of excavation; water from rain event.

The UST was removed and measured 9 ft long and 5.3 ft in diameter (**Figure 5-10**). The final excavation measured approximately 19 ft by 19 ft and 6.5 ft deep. The tank was in good condition. The excavation contained gray and grayish-black soil with a petroleum odor and PID readings up to 25 ppm. The contamination was reported to the NYSDEC Spill Hotline and was recorded as Spill No. 9910434. Approximately 75 cubic yards of contaminated soil were removed from the excavation. The excavation was backfilled to grade with clean fill after collecting two soil samples.

Based on the elevated concentrations of VOCs and SVOCs detected from the former Building 430 UST excavation, additional petroleum contaminated soil was removed. The contaminated soil was observed at depths below 1-3 ft bgs. The contaminated soil was silt and clayey-silt, stained gray and black with a strong fuel oil odor and PID readings up to 147 ppm. Groundwater was encountered at 7 ft bgs. The final excavation measured 21 ft by 19 ft and 8 ft deep (Figure 5-11). Approximately 85 cubic yards of contaminated soil were removed from the excavation for offsite disposal.

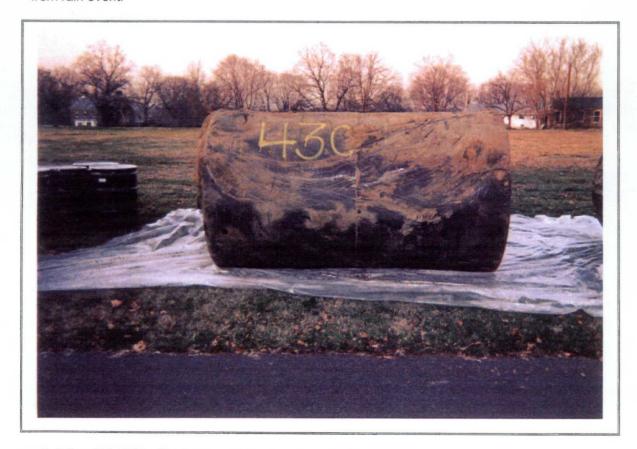
Building 430 UST - Tank temporarily staged on plastic.

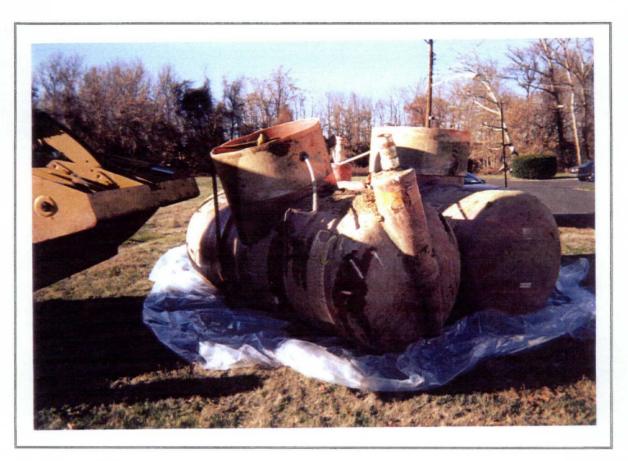
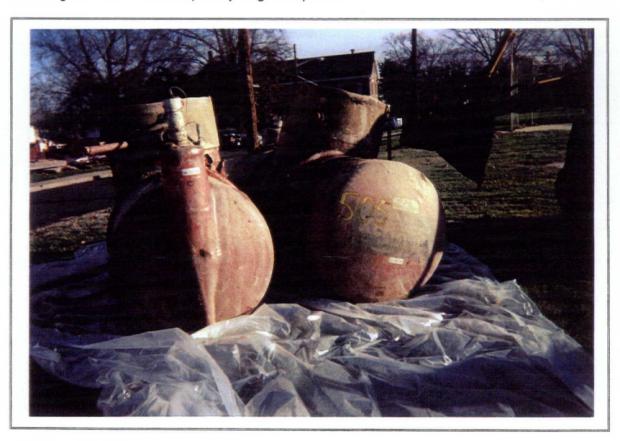
Building 505 UST - Tank temporarily staged on plastic.

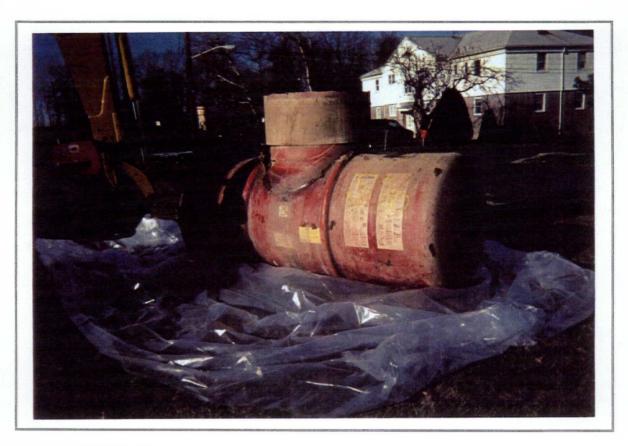
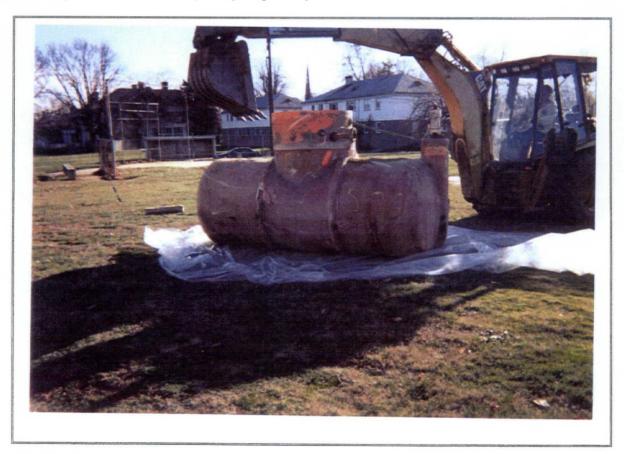
Building 506 UST - Tank temporarily staged on plastic.

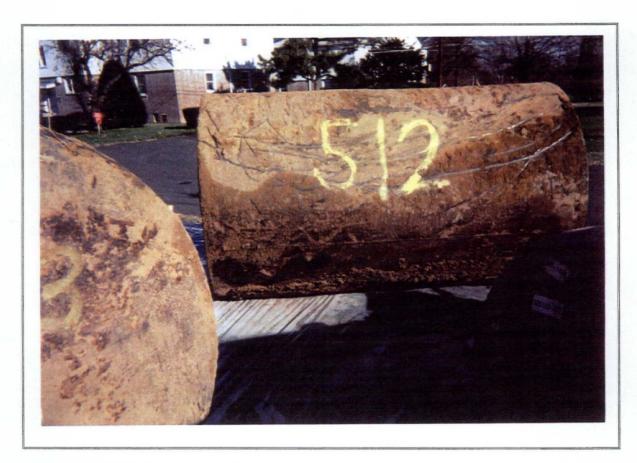
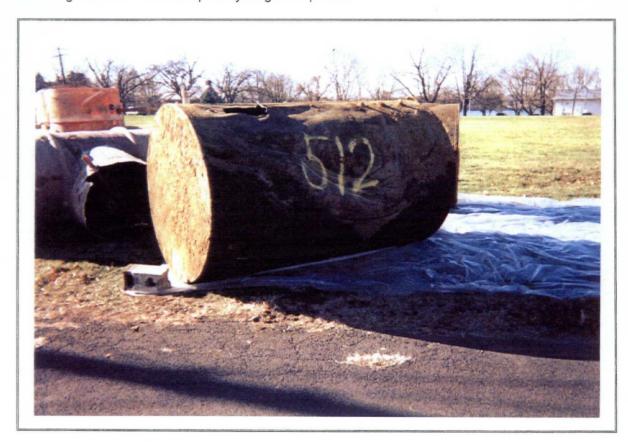
Building 512 UST - Tank temporarily staged on plastic.

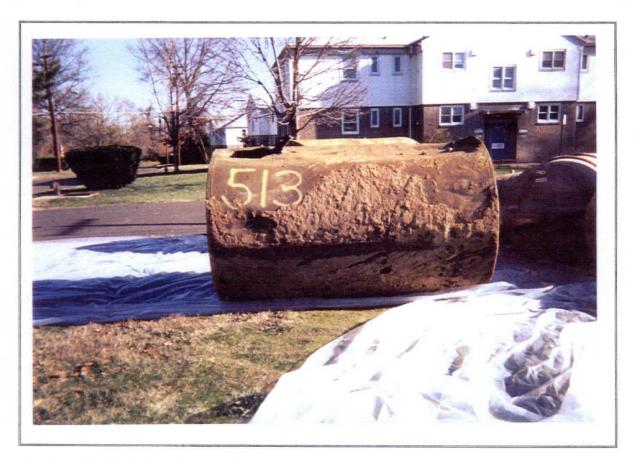
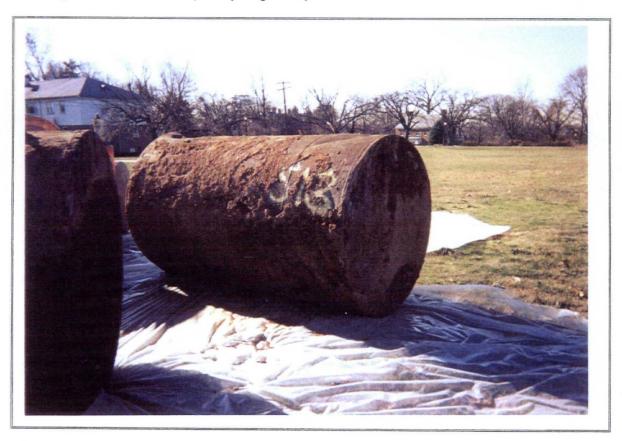
Building 513 UST - Tank temporarily staged on plastic.
